CIRCOLARE Titolo: Sicurezza della Navigazione

Non di serie n.: 05/2018

Oggetto: Defective immersion suit – MED 1/1.7

Safety Alert 3-18

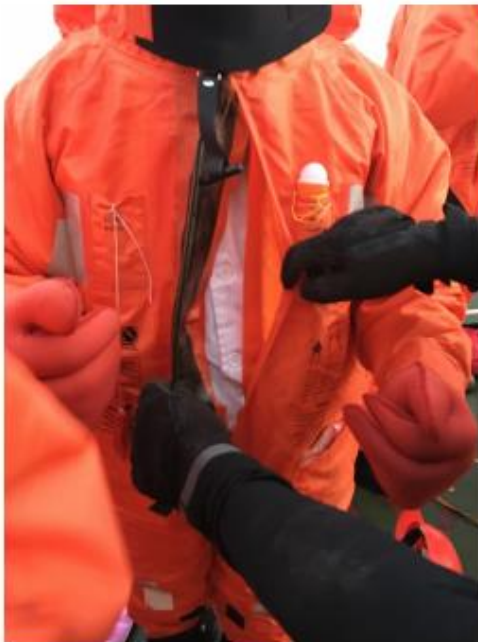
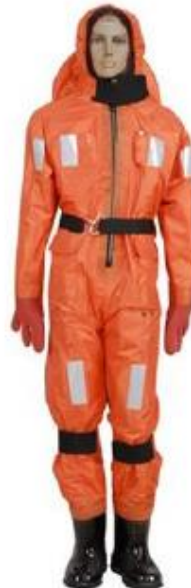
During a recent inspection, U.S. Coast Guard Port State Control examiners discovered a significant flaw involving almost all of a vessel's immersion suits. The examiners noted that the glue used to attach the main zipper to the body of the suit had failed. Failure of the suit at this location will prevent the suit from achieving a watertight seal. Such conditions present serious risk to crewmembers in a survival situation.

Due to the high failure rate discovered during the Coast Guard exam (35 out of 40 suits were defective), the Coast Guard strongly recommends that vessel operators inspect their Immersion Suits for this potential unsafe condition. Do not wait to discover the problem during a real emergency. As a reminder, any replacement survival suits need to be approved by the vessel's Flag State.
